NOTICE OF PROJECT CLOSEOUT

6. Project Title BEHAVIOR OF ARCHITECTURAL NONSTRUCTURAL COMPONENTS IN THE MEXICO EARTHQUAKE				
PART II—SUMMARY OF COMPLETED PROJECT (FOR PUBLIC USE)				
<p>The research program consisted of a combined field study of building cladding performance during the 1985 Mexico earthquake and supporting analytical and experimental studies of cladding connection systems typical of practice in Mexico City. This research effort was broken down into three phases:</p> <p>1. <u>Phase I</u>: Nonstructural damage survey and evaluation for selected buildings in Mexico City.</p> <p>Perishable data on damage to building architectural components and contents was obtained but valuable data was lost as buildings were demolished or cosmetic repairs were made to return buildings to service as rapidly as possible. Nonetheless, from the survey of 25 buildings with heavy cladding systems in Mexico City, 10 of 18 buildings on the lake bed showed good cladding performance, 3 of 18 showed fair performance, and 5 of 18 were rated as having poor cladding performance; all 7 of the buildings on the transition zone had good cladding performance.</p> <p>2. <u>Phase II</u>: Laboratory testi

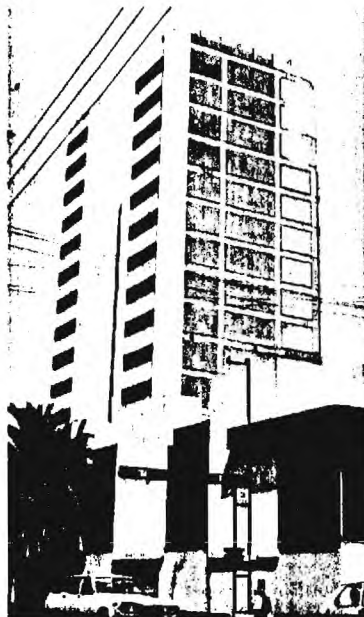
Figure 4 - Building 3

Figure 5 - Building 3 Panel Delamination

Building 3: This 15 story concrete frame structure with waffle slabs (Fig. 4) was unsymmetric in plan and experienced heavy damage to the framing and masonry infill walls. The cladding system was composed of heavy precast panels which were attached to the masonry infill by mortar reinforced with 1/8 inch steel wire tied to 4 inch nails driven into the brick masonry (see Fig. 15). The cladding panels delaminated from the mortar backing (Fig. 5) and were in danger of falling from the structure. The structure was closed following the earthquake pending a decision to repair or demolish.

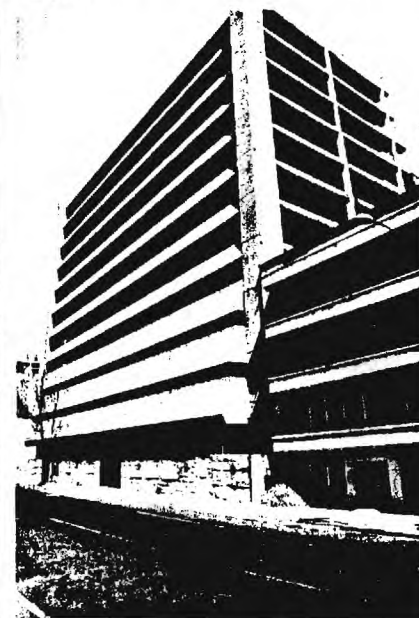
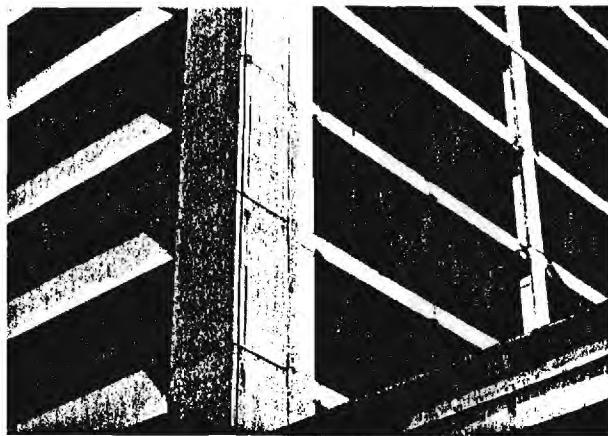
Figure 6 - Building 5

Fig. 7a. Building 5 Cladding and Column-Slab Failures

Figure 7b - Close-up of Building 5 Column Cover Cladding Failure

Figure 7c - Building 5 Cladding Failure

Building 5: The 11 story concrete frame structure with waffle slabs shown in Fig. 6 had extensive structural damage, primarily at the joints. The precast column cover panels were attached to plates embedded in the floor slabs (see Figs. 16,17) and experienced extensive racking at the corners at the location of the plate inserts in the panels (see Figs. 7a,b,c). The spandrel facade panels along the inclined front face of the structure were not damaged. This structure was chosen from those in the Phase I survey for detailed analytical evaluation in Phase III (see discussion below). The weld plate inserts in the panels are similar in concept to

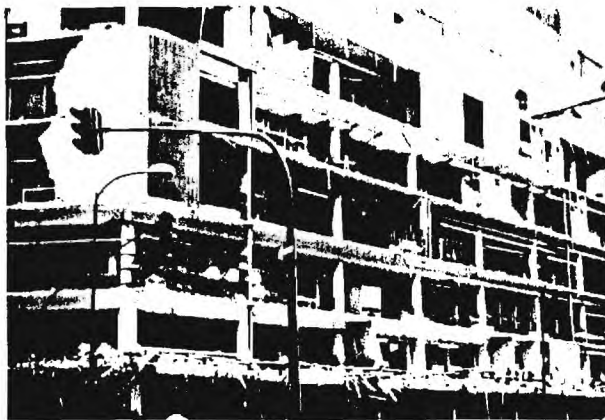
Figure 9 - Building 13 (Cladding failed but structure survived)

Building 13: The structure in Fig. 9 was in good condition following the earthquake, but the masonry facade failed due to insufficient anchorage at the base and had to be completely replaced. This type of masonry infill facade is quite common in Mexico, particularly for the side and rear faces of the building; architectural panels are generally reserved for the front of the building. The building was designed using the 1962 code.
